## Property Inspection Report

**Bob & Sarah Tinsdale**

2864 51st St., San Diego CA, 92115

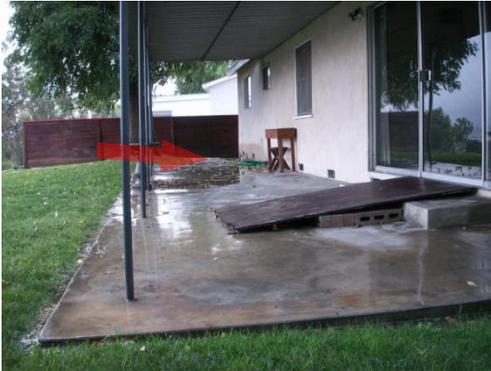
**MAINTENANCE:** The soil level at the backyard is graded improperly near the concrete patio and slopes towards the building (see photo below). This can allow water to collect near the structure. Recommend grading soil so it slopes down and away from the building to direct rainwater away.

Figure 2: concrete patio sloped toward home

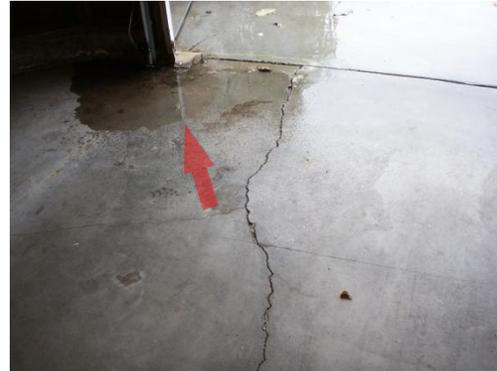
**DEFECTIVE:** The driveway near the entrance to the home is sloped toward the garage and is allowing water to enter the garage space. Recommend further evaluation by a licensed professional.

Figure 3: water entry into garage

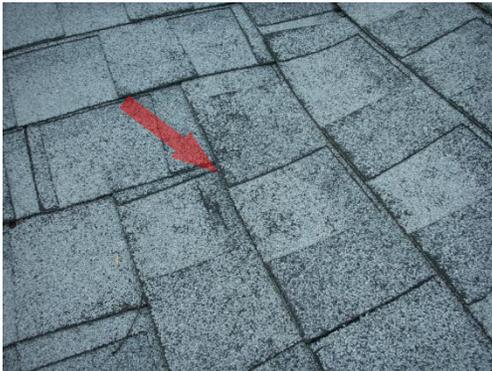
**MONITOR:** The roof covering is deteriorating as expected for the age of the roof. Granules are missing in some areas. Exposed nail heads and all roof penetrations should be sealed to prevent water intrusion.

Figure 4 Roof showing signs of wear

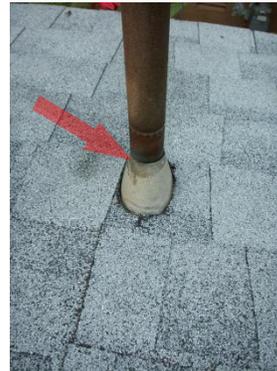
Figure 5: Sealant missing around roof vent

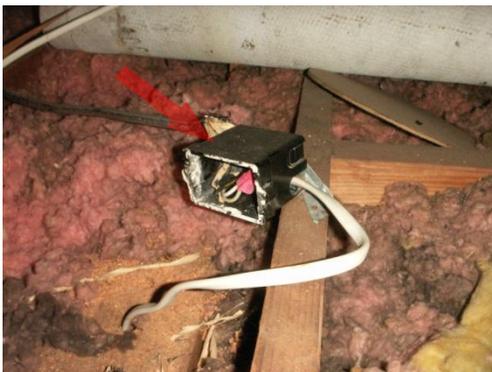
DEFECTIVE: The electrical box found near the attic access should have a tight fitting cover. Several of the attic vents were blocked by the loose fill insulation. This can negatively impact the life expectancy of the roof. We recommend clearing the insulation away and installing a product commonly referred to as an "insulation dam" to prevent this.

Figure 6: open electrical box near attic entrance

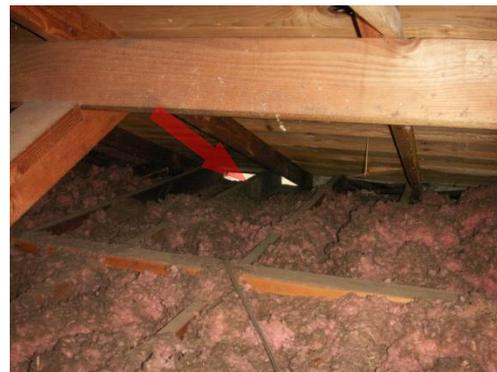
Figure 7: view of attic showing open vent

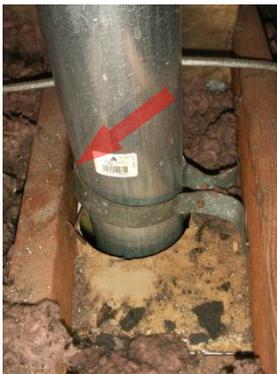
DEFECTIVE: One inch of clearance must be maintained between B-Vent furnace pipe and combustibles. As the photo shows, the framing member to the left is too close and the insulation should be cleared and a dam placed in this area to prevent insulation from encroaching into this clear space.

Figure 8: furnace vent in attic

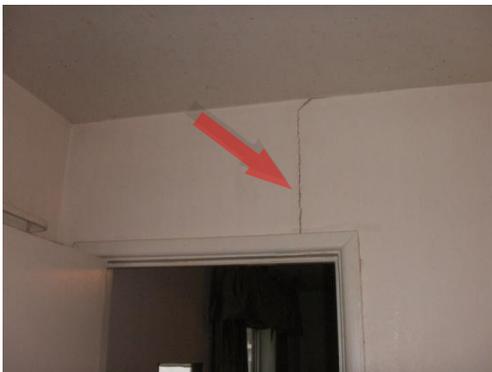
Figure 9: door to hall bedroom

EVALUATE: Cracking observed at several locations near interior doors and windows. This could be normal for the age of the building or it could indicate building movement. Recommend review by licensed professional prior to the close of escrow.

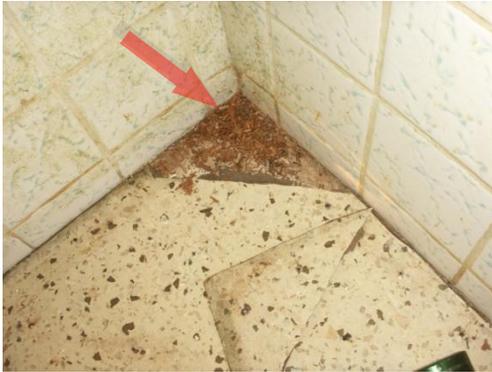
**MAINTENANCE:** The subfloor at the hall bathroom has evidence of water damage near the toilet and again between the tub and vanity cabinet. The floor is deemed serviceable at present, but will need to be replaced at some point or certainly during any renovation.

Figure 11: subfloor damage in hall bath

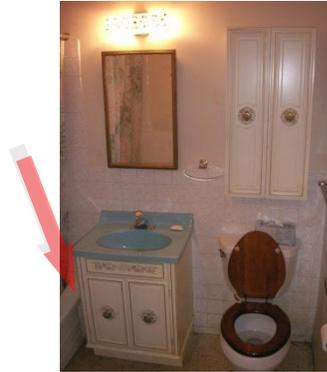
Figure 12: floor is damaged here

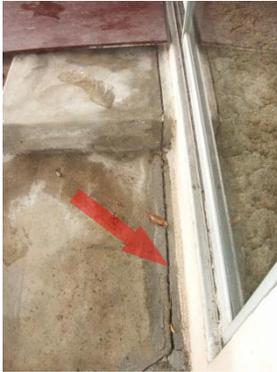
MAINTENANCE: Typical cracking noted at most concrete surfaces. These cracks should be sealed with a caulking specifically designed for this purpose to prevent water intrusion. The rear patio has settled and a crack is present between the house foundation and the patio. This is not typical; however it is fairly common in a home of this age. Again, recommend caulking with a good quality sealant and monitor for further movement.

Figure 13: rear patio crack

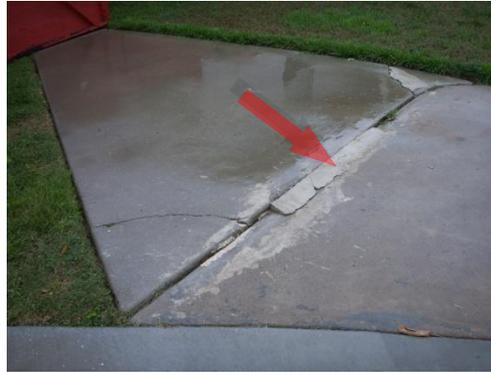
**SAFETY:** The concrete walkway leading from the driveway to the side gate is elevated and could present a trip hazard. Recommend adding material to create a smooth transition or grinding the elevated section down to meet the lower section.

Figure 14: raised concrete at front driveway

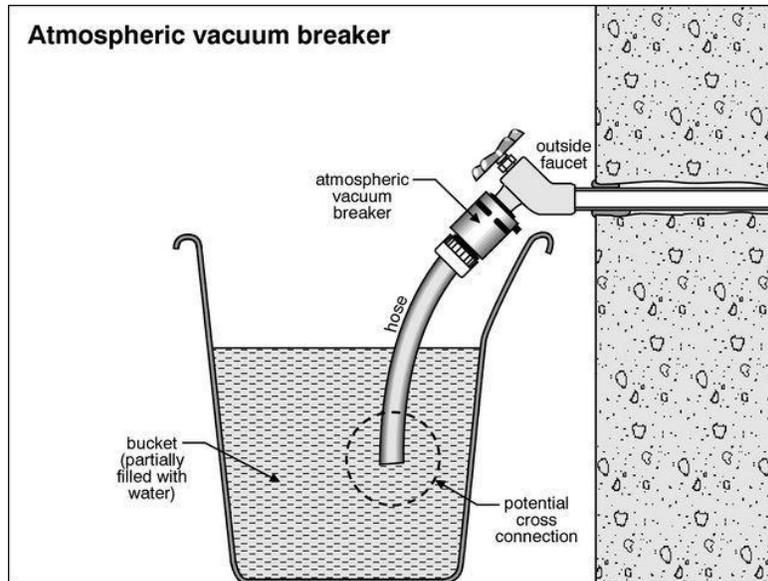
IMPROVE: Backflow preventers (atmospheric vacuum breakers) were not noted on all exterior hose bibs but should be installed as required by current standards. These are inexpensive products that can be attached without special tools which prevent contaminated water from being siphoned back into the potable water lines during city water pressure outages.

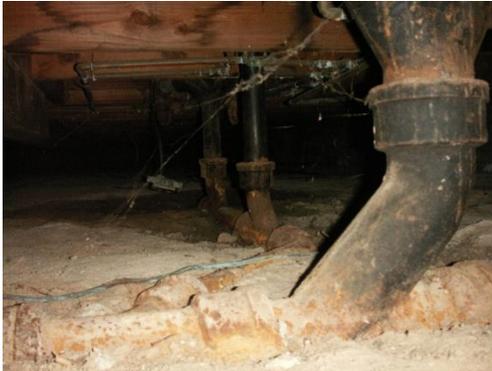
**MONITOR:** The sink and tub in the master bath drain slower than the equivalent components in the hall bath. These fixtures share the same plumbing system so it is likely that the blockage is near the fixtures as opposed to deeper within the plumbing system.

Figure 16: view of plumbing system from crawlspace

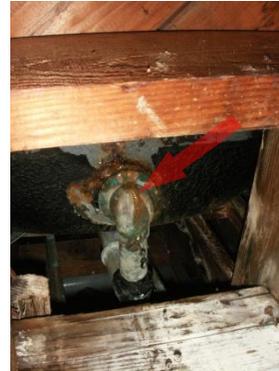
**DEFECTIVE:** The tub drain in the master bathroom is leaking. In the inspectors opinion it appears to be leaking at the junction where the plumbing drain meets the tub.

Figure 17: active leak
