## Property Inspection Report

**Bob & Sarah Tinsdale**

2864 51st St., San Diego CA, 92115

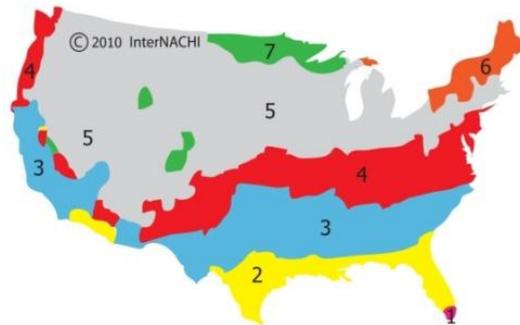
### R-VALUE RECOMMENDATIONS

IMPROVE: Insulation levels are lower than ideal at approximately R6 to R8. You will realize some energy savings should you decide to follow the guidelines in the illustration below.

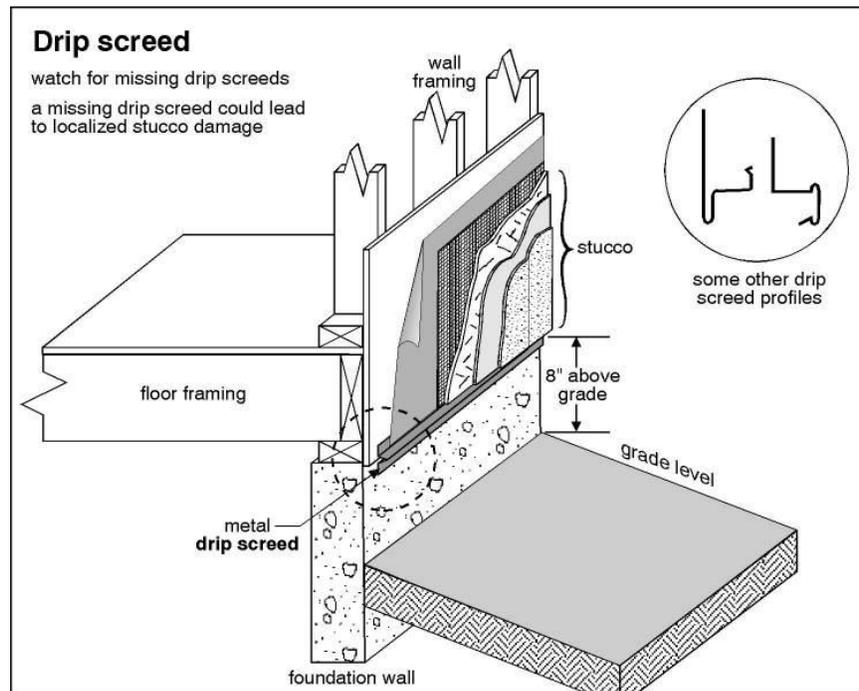
This spacing also allows moisture to escape, preventing wood-destroying pests and organisms, and helps prevent blistering and sloughing of the stucco. Recommend regular homeowner monitoring and maintenance. For a good read on how to moisture proof the exterior cladding of your home, go here: [http://www.epa.gov/indoorairplus/technical/moisture/1\\_5.html](http://www.epa.gov/indoorairplus/technical/moisture/1_5.html). A cross section of an improved wall system can be seen below.

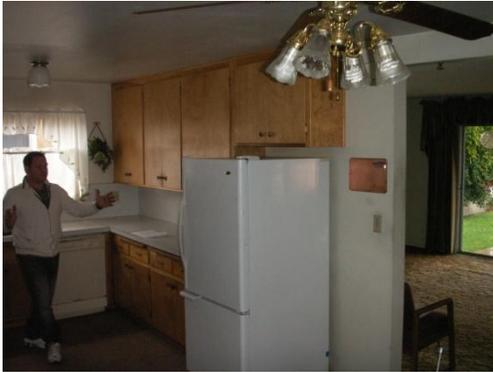
Figure 18: view of the kitchen

IMPROVE. Client indicates that the kitchen will be completely remodeled and a cursory overview was what Client was requesting in this area. From that perspective, the cabinetry appeared serviceable at the time of inspection. Doors and drawers functioned as expected for the age of the millwork.
